Winter Harbor Sargent St. Route

Bicycle/Pedestrian Hazards

These observations were made during an assessment of this route on May 30, 2017.

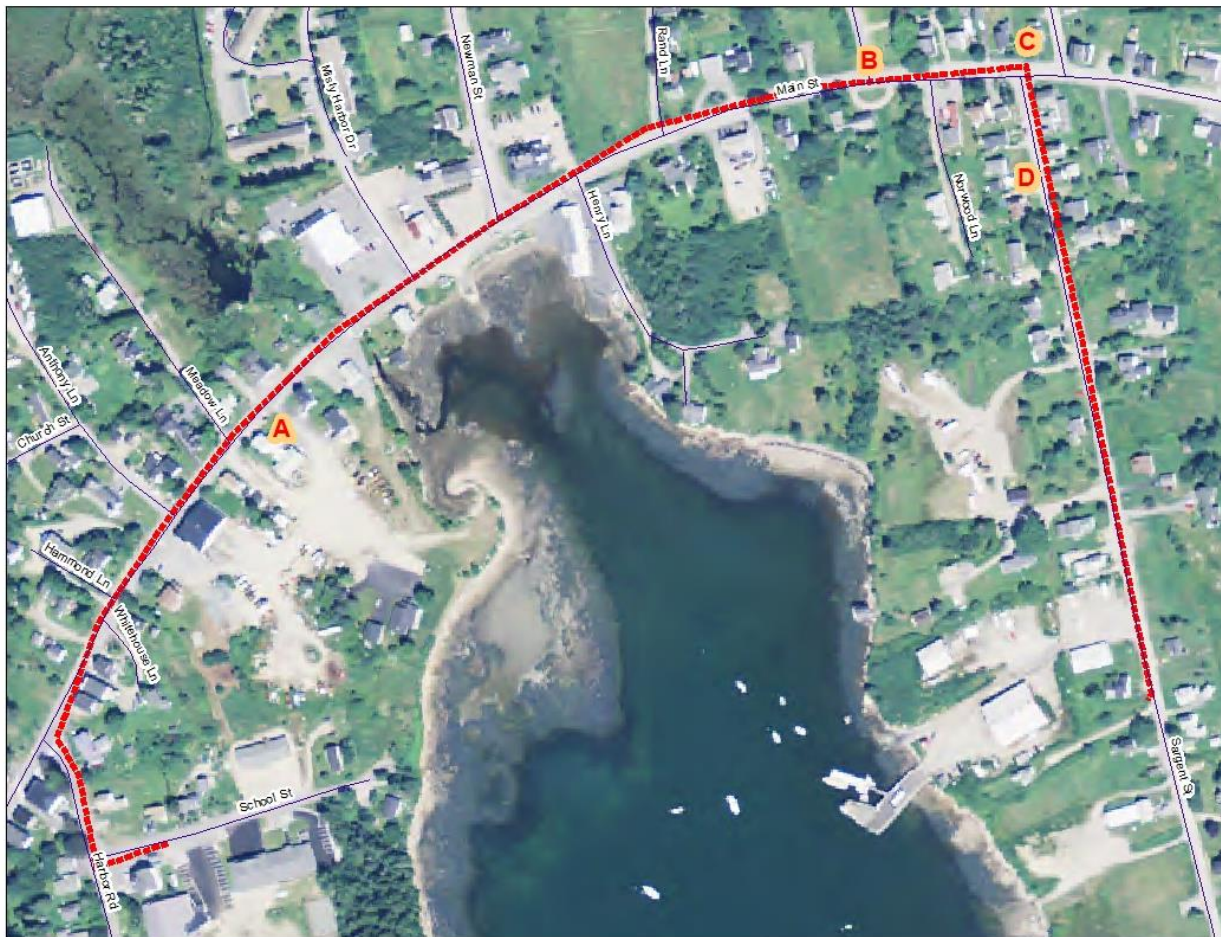
- A. There is loose sediment collects on the sidewalk and road shoulder along Main St., which can cause traction hazards for pedestrians, bicyclists, and wheelchair-bound users.

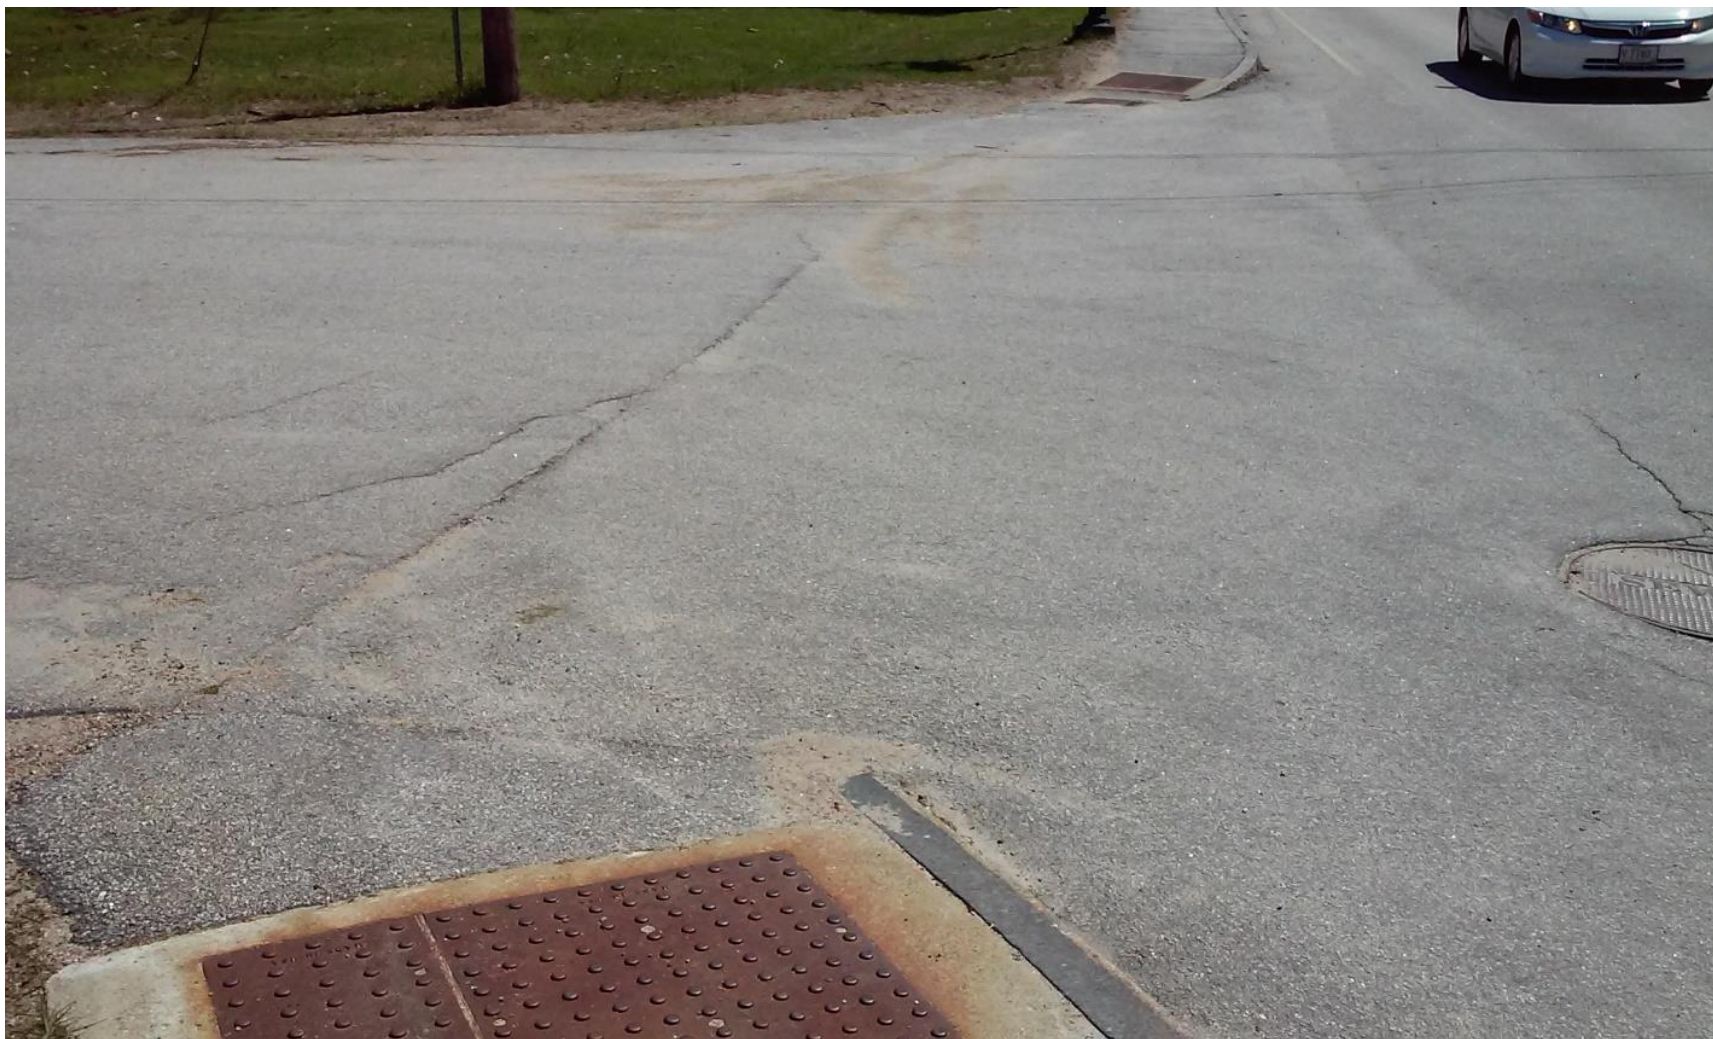
B. There is no crosswalk at the intersection of Ocean Heights Dr. and Main St. needs to be repainted.

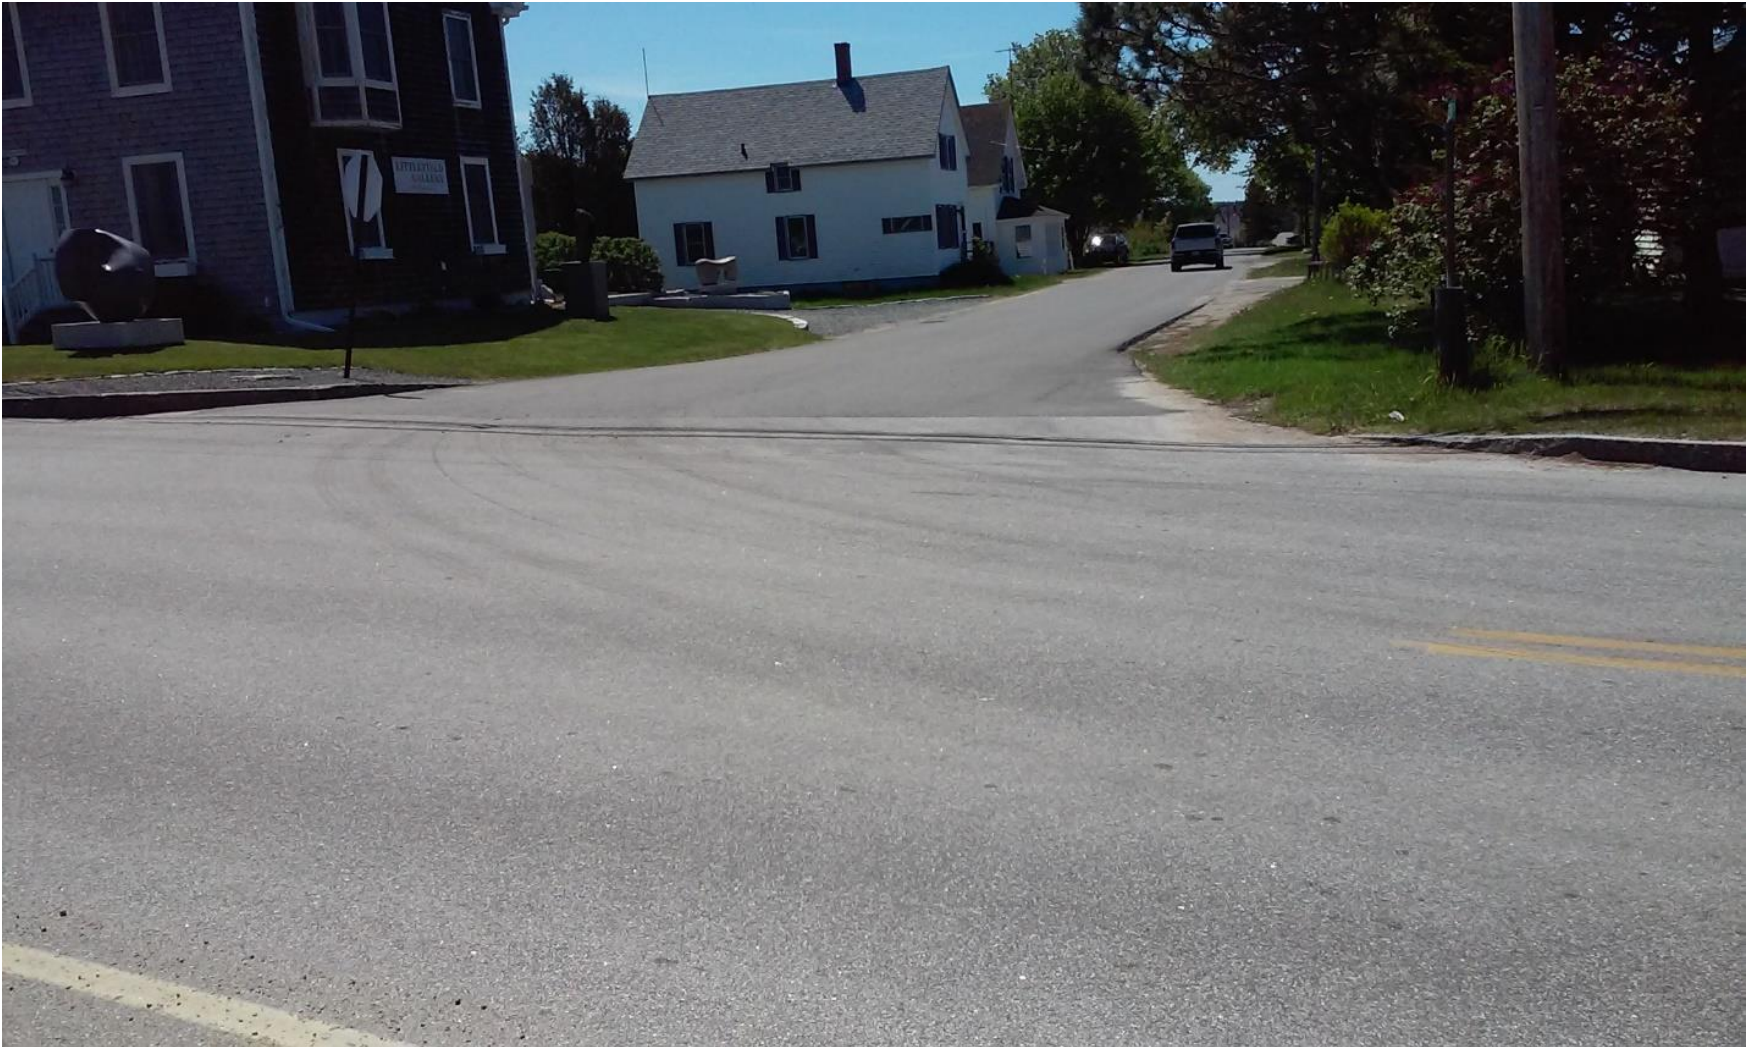
- C. The crossing from the sidewalk on Main St. to Sargent St has several safety hazards:
 - a. There is no curb cut or crosswalk.

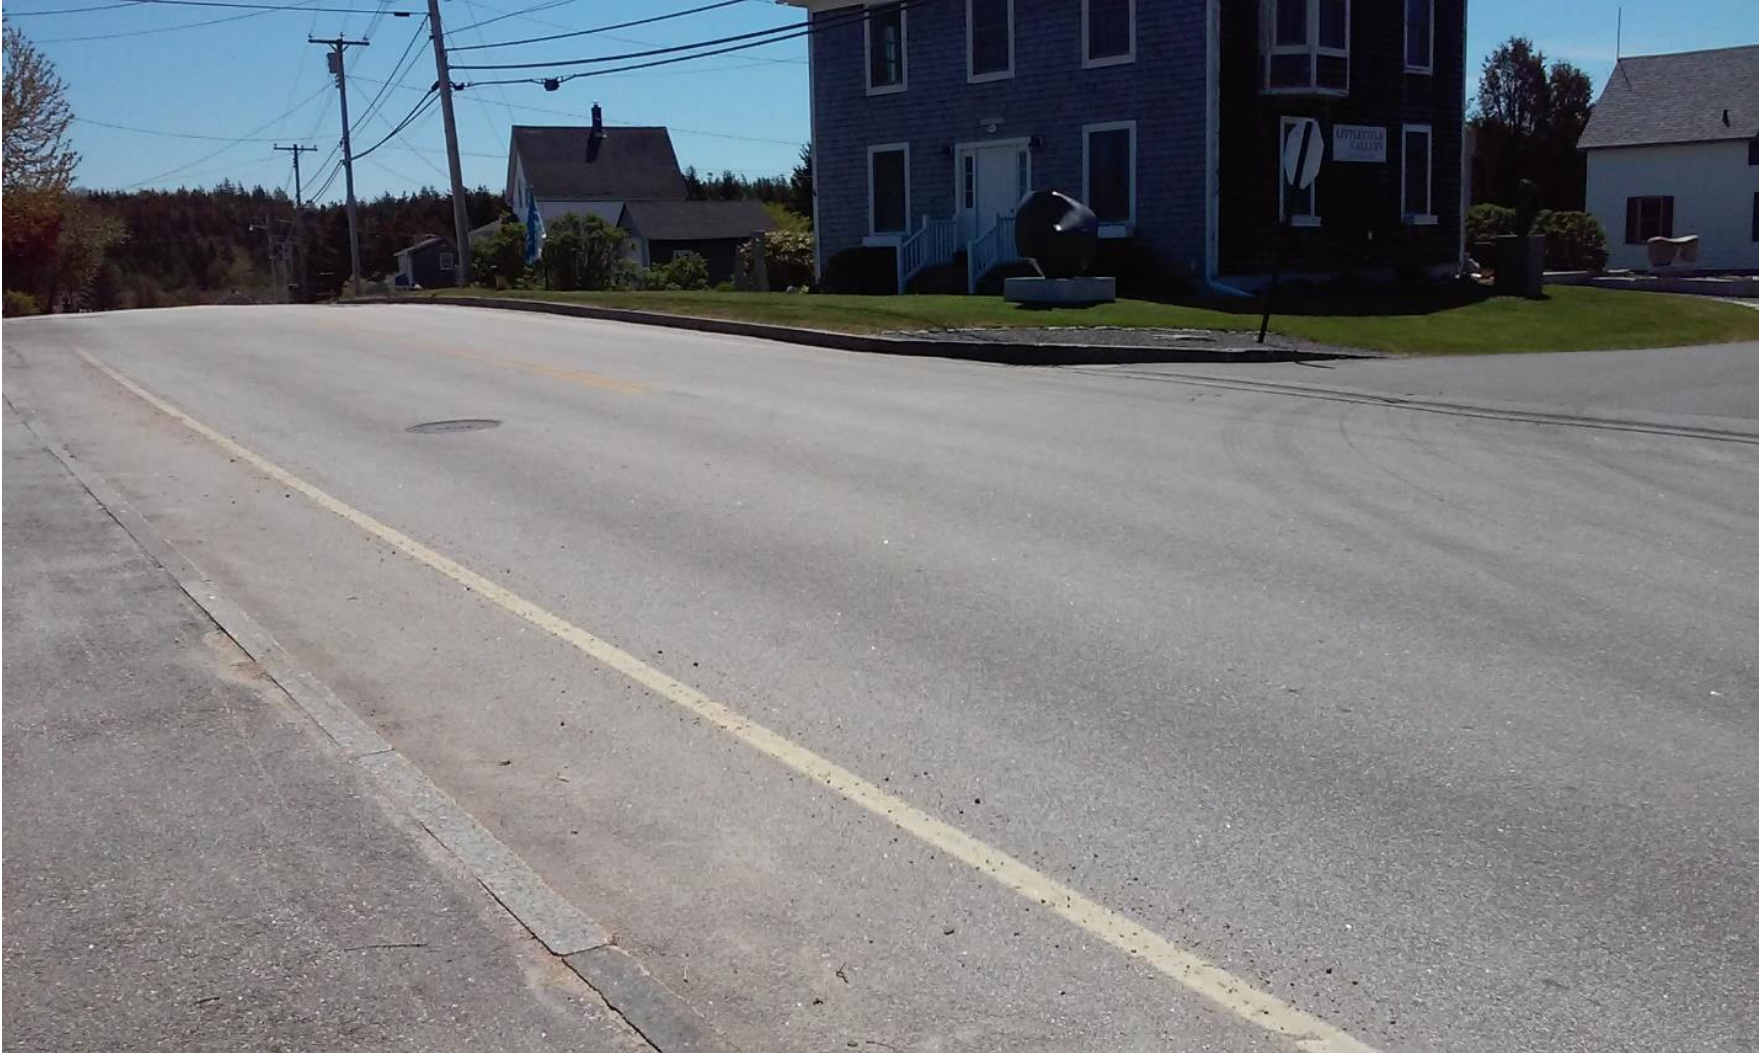
- C. The crossing from the sidewalk on Main St. to Sargent St has several safety hazards:
 - b. There is no visibility of oncoming traffic from the east.

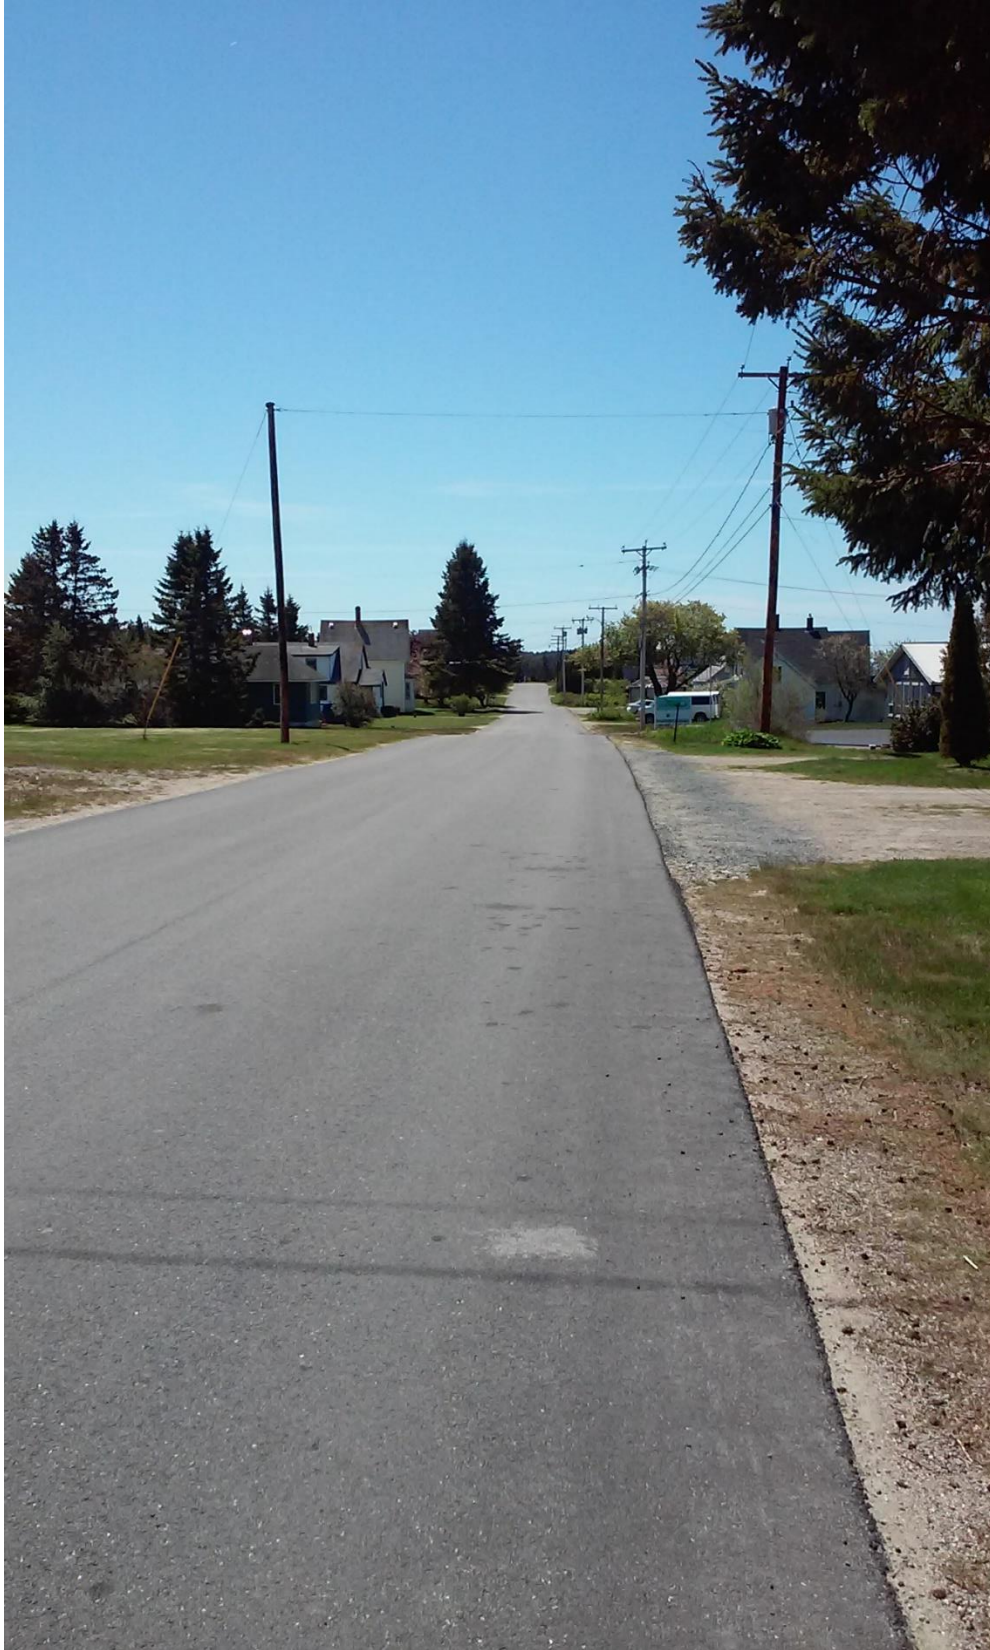
D. There is no sidewalk or painted shoulder on Sargent St.
